EM 1110-2-2002

30 June 1995

Engineering and Design
EVALUATION AND REPAIR OF CONCRETE STRUCTURES

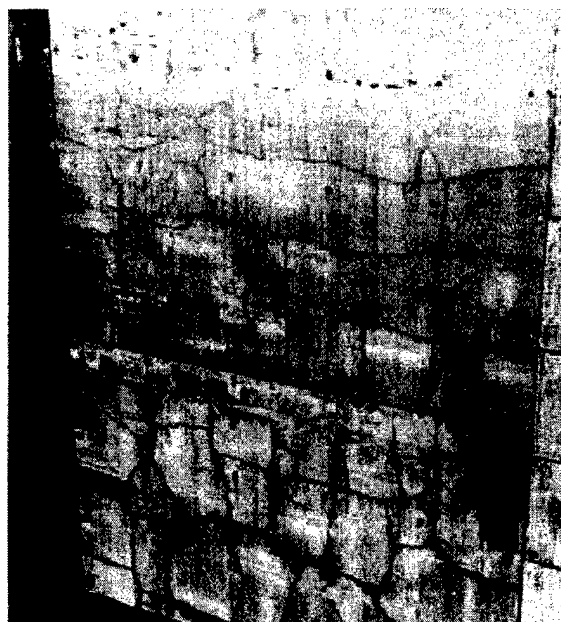
Figure 2-5. Pattern cracking caused by restrained volume changes

(a) Surface appearance of cracks. The surface appearance of cracks can give the first indication of the cause of cracking. Pattern cracks (Figures 2-5 through 2-7) are rather short cracks, usually uniformly distributed and interconnected, that run in all directions. Pattern cracking indicates restraint of contraction of the surface layer by the backing or inner concrete or possibly an

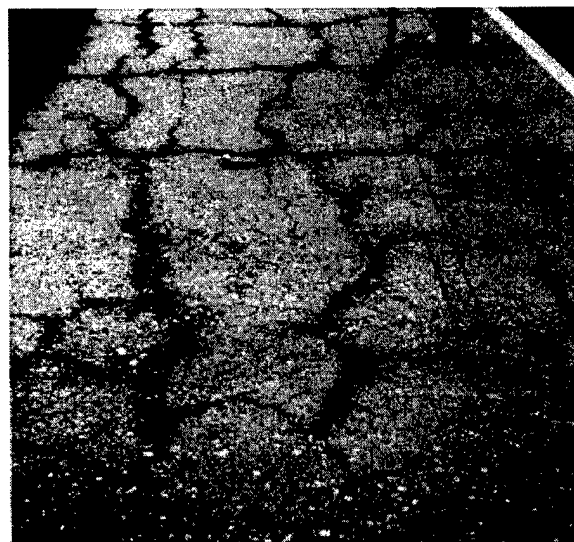
Figure 2-6. Pattern cracking resulting from alkali-silica reaction

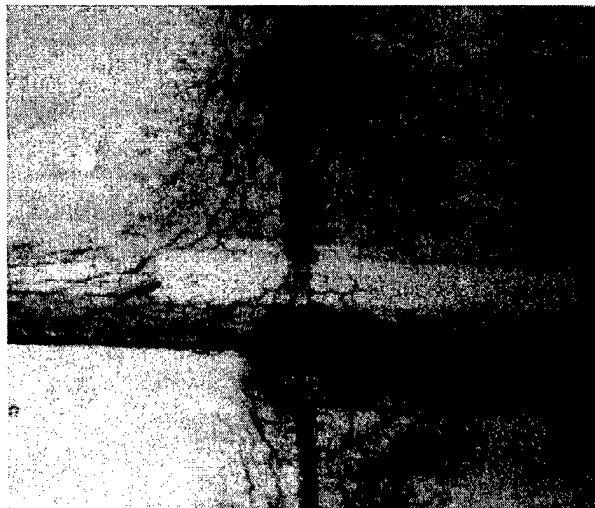
Figure 2-8. D-cracking in a concrete pavement

increase of volume in the interior of the concrete. Other terms used to describe pattern cracks are map cracks, crazing, and checking (see Glossary, Appendix B, for definitions). Another type of pattern crack is D-cracking. Figure 2-8 shows typical D-cracking in a concrete pavement. D-cracking usually starts in the lower part of a concrete slab adjacent to joints, where moisture accumulates, and progresses away from the corners of the slab. Individual cracks (Figures 2-9 through 2-11) run in definite directions and may be multiple cracks in parallel at definite intervals. Individual cracks indicate tension in the direction perpendicular to the cracking. Individual cracks are also frequently referred to as isolated cracks. Several terms may be used to describe the direction that an individual or isolated crack runs. These terms include diagonal, longitudinal, transverse, vertical, and horizontal.

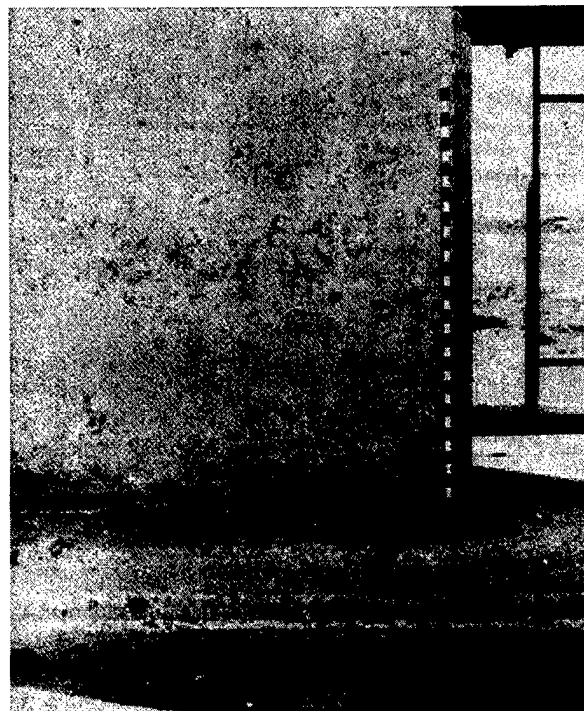
Figure 2-16. Light scaling

(a) Scaling. Scaling is the localized flaking or peeling away of the near-surface portion of the hardened concrete or mortar. Scaling is frequently a symptom of freezing and thawing damage. Degrees of concrete scaling may be defined as follows (ACI 201.1R). Light spalling is loss of surface mortar without exposure of coarse aggregate (Figure 2-16). Medium spalling is loss of surface mortar up to 5 to 10 mm (0.2 to 0.4 in.) in depth and exposure of coarse aggregate (Figure 2-17). Severe spalling is loss of surface mortar 5 to 10 mm (0.2 to 0.4 in.) in depth with some loss of mortar surrounding aggregate particles 10 to 20 mm (0.4 to 0.8 in.) in depth, so that

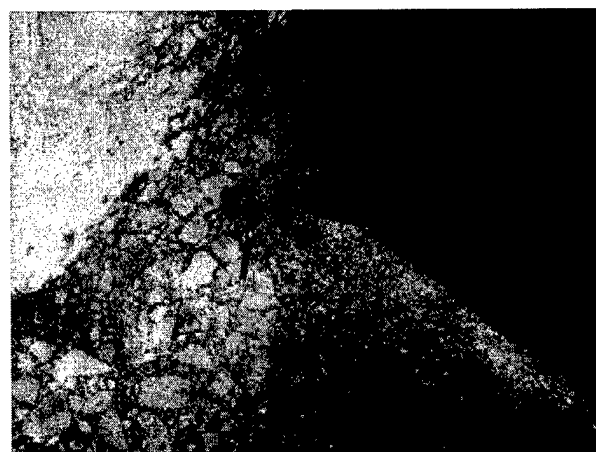
Figure 2-20. Smooth, worn, abraded concrete surface caused by abrasion of waterborne debris

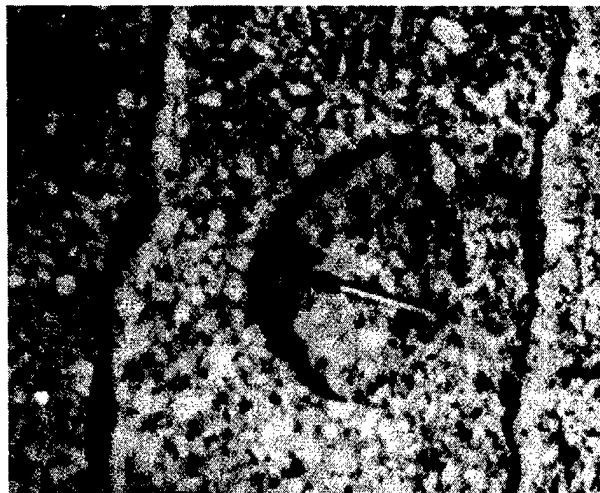
Figure 2-29. Small spall

(a) Small spall. Not greater than 20 mm (0.8 in.) in depth nor greater than 150 mm (6 in.) in any dimension (Figure 2-29).

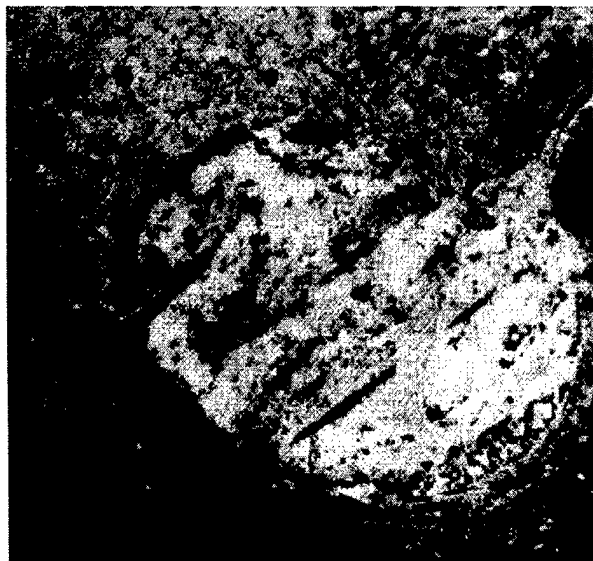
Figure 2-30. Large spall

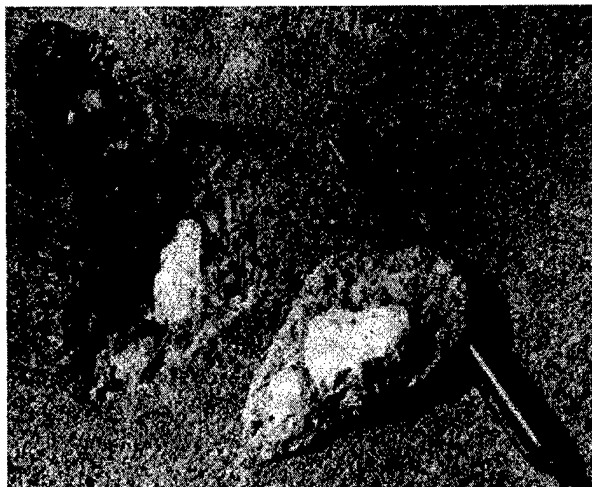
Figure 2-31. Popout

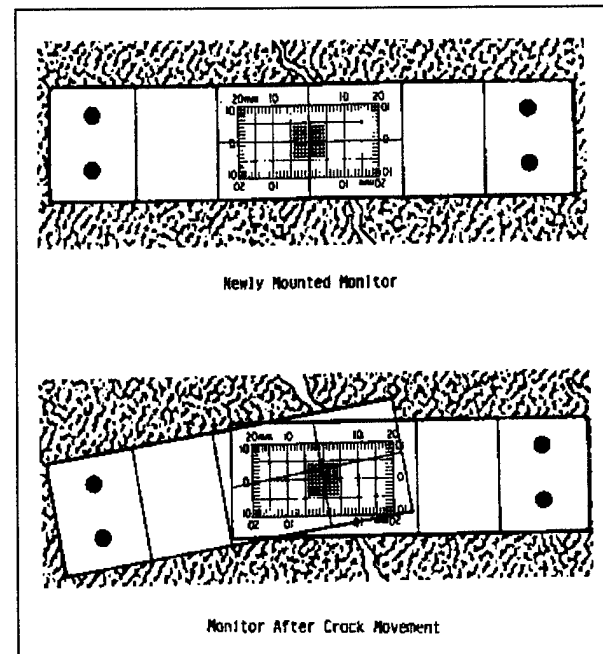
Figure 2-33. Crack monitor

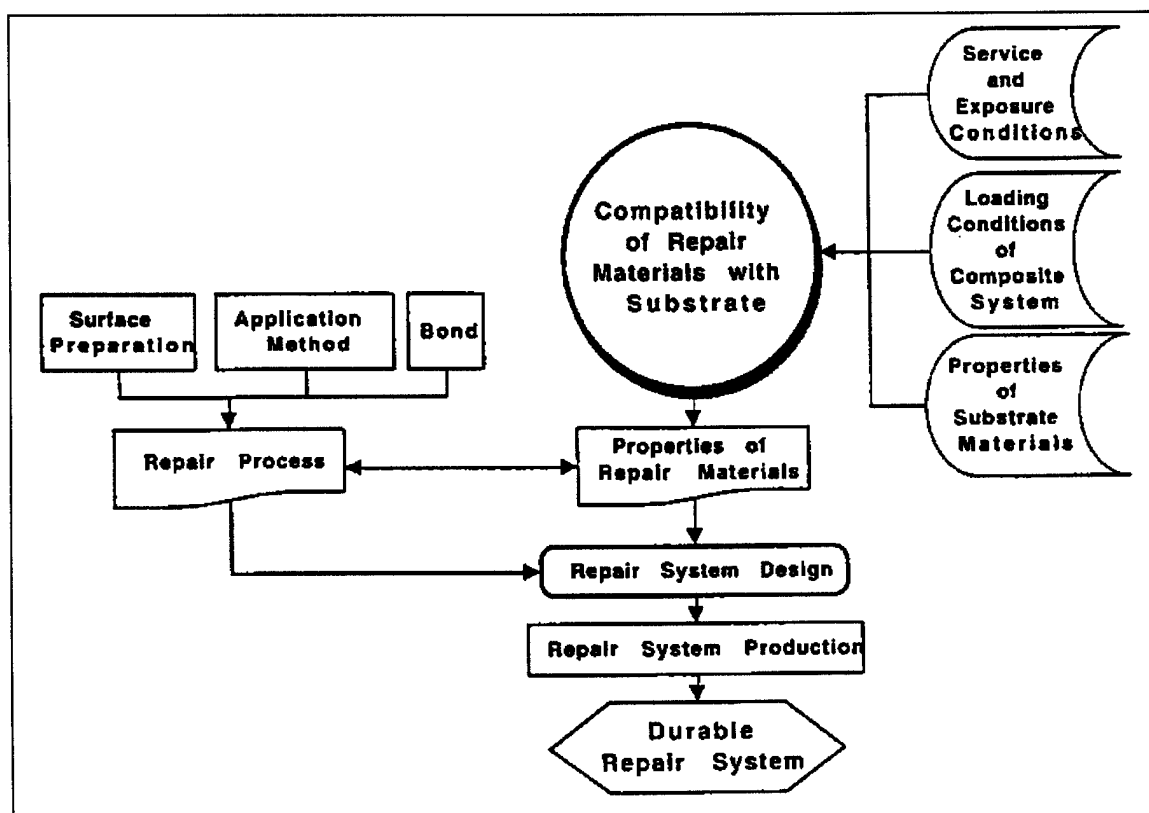
Figure 4-1. Factors affecting the durability of concrete repair systems (Emmons and Vaysburd 1995)

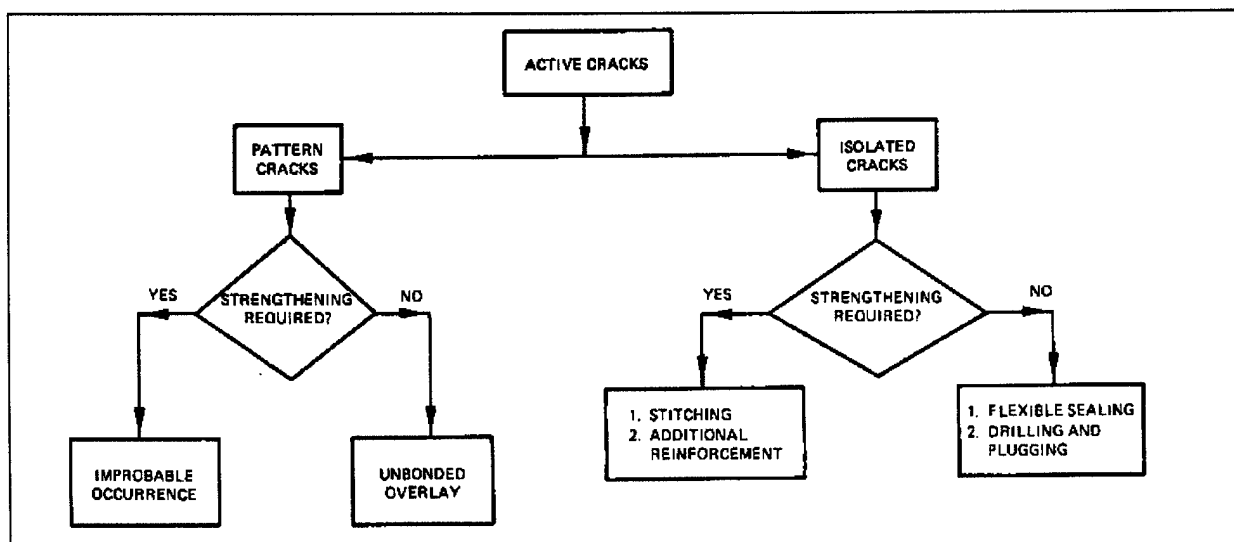
Figure 4-3. Selection of repair method for active cracks (after Johnson 1965)

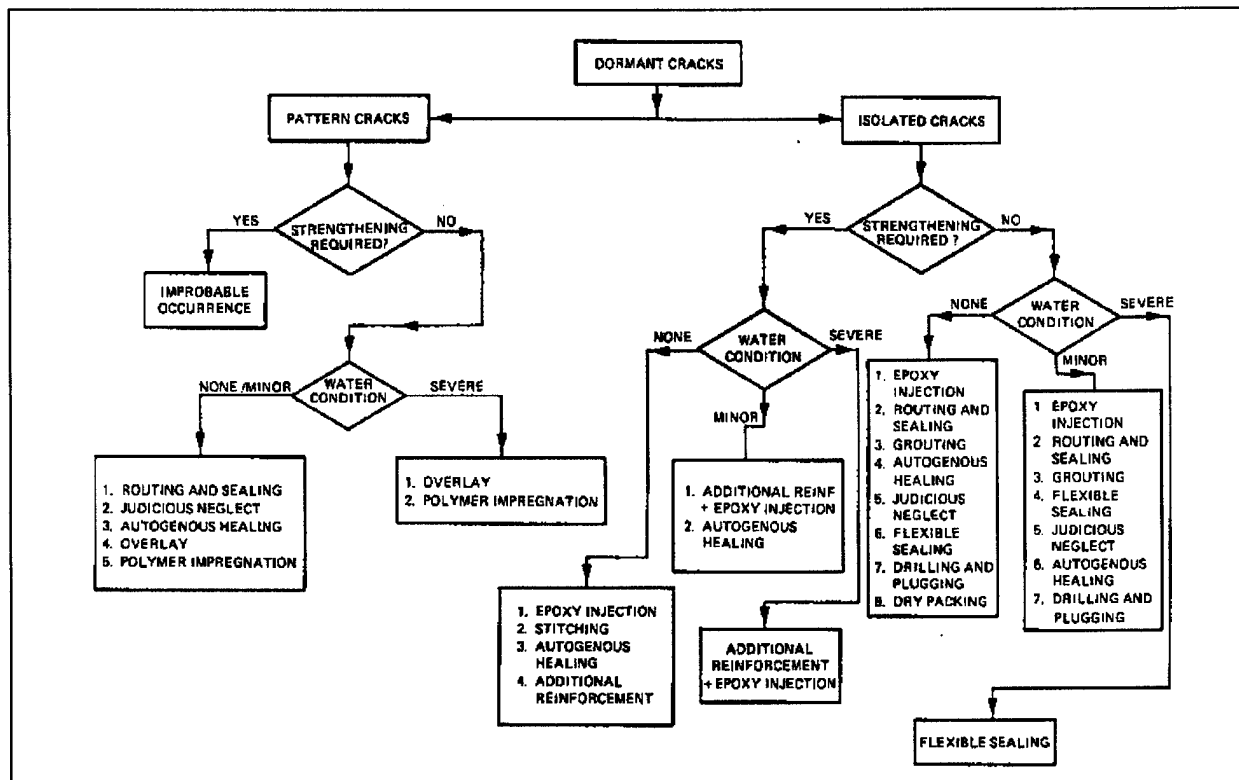
Figure 4-4. Selection of repair method for dormant cracks (after Johnson 1965)

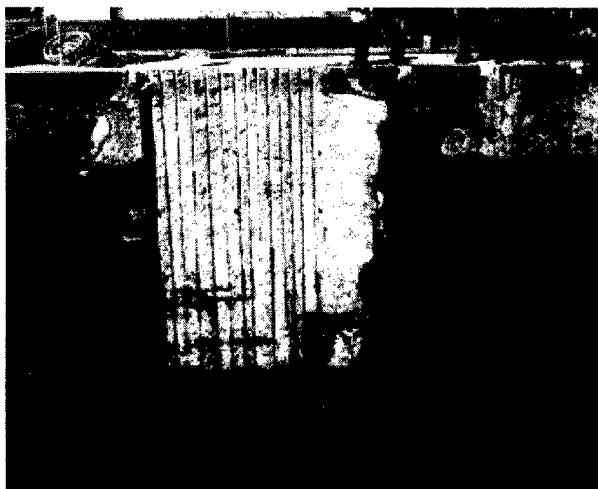
Figure 5-1. Surface removal of deteriorated concrete by explosive blasting

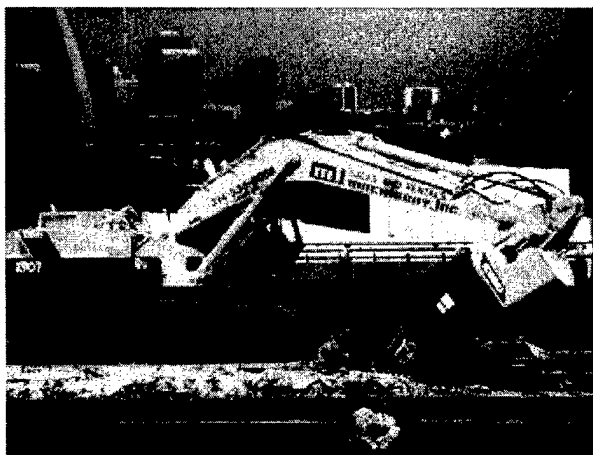
Figure 5-2. Boom-mounted concrete crusher

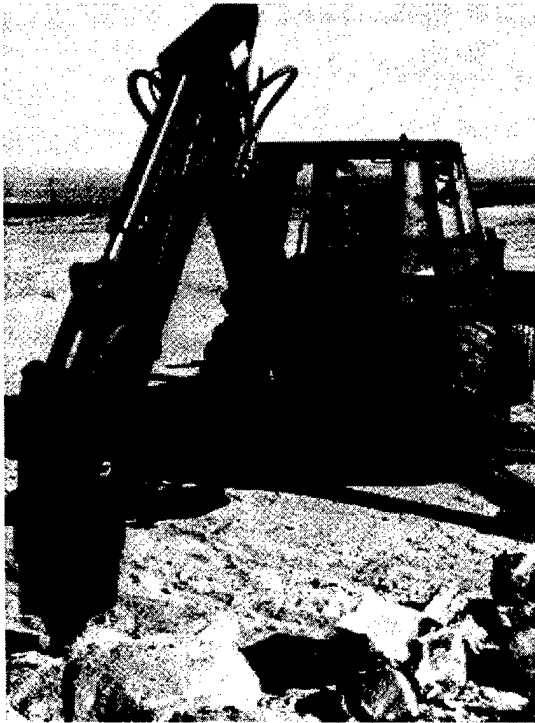
Figure 5-7. Boom-mounted breaker

(1) Boom-mounted breakers. Boom-mounted impact breakers are applicable for both full- and partial-depth removals where production rates required are greater than can be economically achieved by the use of hand-held breakers. The boom-mounted breakers are somewhat similar to the hand-held breakers except that they are considerably more massive. The tool is normally attached to the hydraulically operated arm of a backhoe or excavator (Figure 5-7) and can be operated by compressed air or hydraulic pressure. The reach of the hydraulic arm enables the tool to be used on walls at a considerable distance above or below the level of the machine. Boom-mounted breakers are a highly productive means of removing concrete. However, the blow energy delivered to the concrete should be limited to protect the structure being repaired and surrounding structures from damage resulting from the high cyclic energy generated. Saw cuts

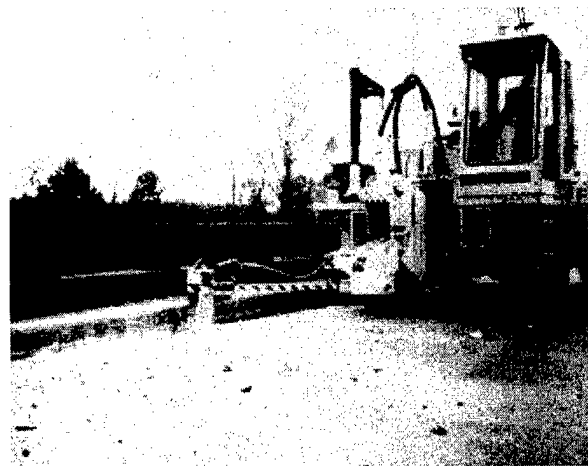
Figure 5-8. Spring-action hammer (mechanical sledgehammer)

(2) Spring-action hammers. Spring-action hammers (sometimes referred to as mechanical sledgehammers) are boom-mounted tools that are applicable for breaking concrete pavements, decks, walls, and other thin members where production rates required are greater than can be economically achieved with the use of hand-held breakers. Hammers are more applicable for total demolition of a concrete member than for removal to rehabilitate or repair. The arm of the hammer is hydraulically powered, and the impact head is spring powered. The spring is compressed by the downward movement of the arm of the backhoe or excavator and its energy released just prior to impact. There are truck units available that make it easier to move between projects. The operation of the hammer and advancement of the truck during removal are controlled from a cab at the rear of truck (Figure 5-8). The blow energy delivered to the concrete should be limited to protect the structure being repaired and surrounding structures from damage caused by the high cyclic energy generated. Saw cuts should be employed at removal boundaries to reduce the occurrence of feathered edges. The concrete that remains may be damaged (microcracking) along with the exposed reinforcing steel.

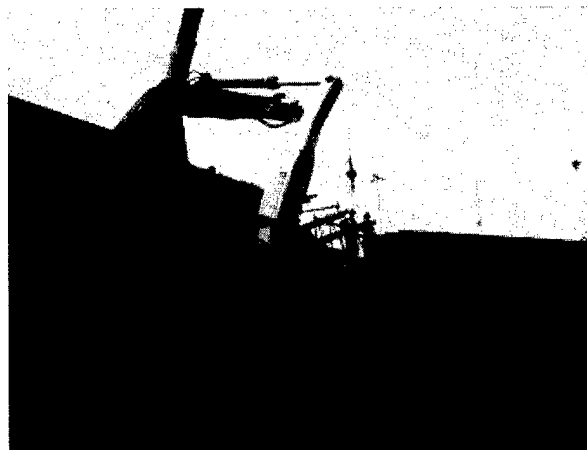
Figure 5-11. Rotary-head milling

(2) Rotary-head milling. Method is applicable for removing deteriorated concrete from mass structures (Figure 5-11) and for removing deteriorated concrete cover from reinforced members such as pavements and decks where its contact with the reinforcement is unlikely. Removal is limited to concrete outside structural steel reinforcement. Significant loss of productivity occurs in sound concrete. For concrete having a compressive strength of 55 MPa (8,000 psi) or greater, rotary-head milling is not applicable. Concrete that remains may be

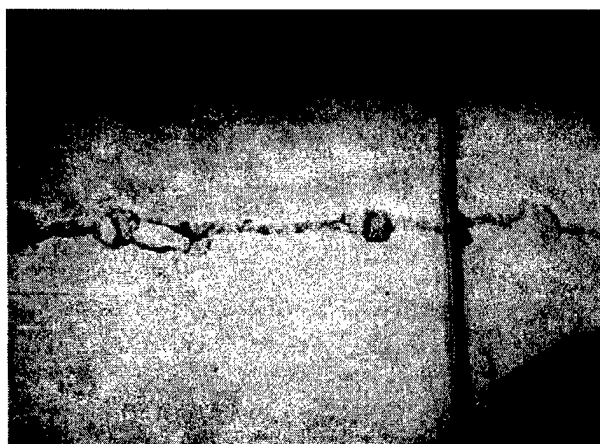
Figure 5-12. Presplitting using chemical-expansive agent

(1) Chemical presplitting, expansive agents. The presplitting method that uses chemical-expansive agents (Figure 5-12) is applicable for removal from slabs, walls, and other concrete members where depth of boreholes is 10 times the borehole diameter or greater. It is especially applicable for situations requiring the development of vertical presplitting planes of significant depth. The main disadvantages of employing expansive agents are cost and application-temperature limitations. Personnel must be restricted from the presplitting area during early hours of product hydration as the material has the potential to blow out of boreholes and cause injury. Expansive products that are prills or become slurries when water is added are best used in gravity filled, vertical or near-vertical holes. Some products form a clay-type material when mixed with water that allows the material to be packed into

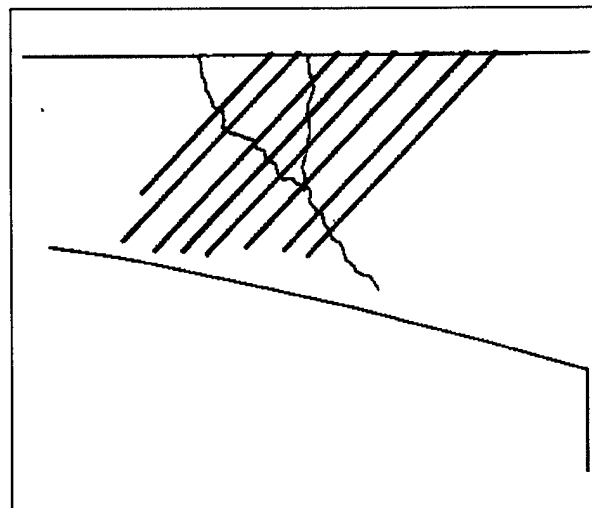
Figure 6-1. Crack repair using conventional reinforcement with drillholes 90 deg to the crack plane

(a) This technique consists of sealing the crack, drilling holes 19 mm (3/4 in.) in diam at 90 deg to the crack plane (Figure 6-1), cleaning the hole of dust, filling the hole and crack plane with an adhesive (typically epoxy) pumped under low pressure 344 to 552 KPa (50 to 80 psi), and placing a reinforcing bar into the drilled hole. Typically, No. 4 or 5 bars are used, extending at least 0.5 m (1.6 ft) on each side of the crack. The adhesive

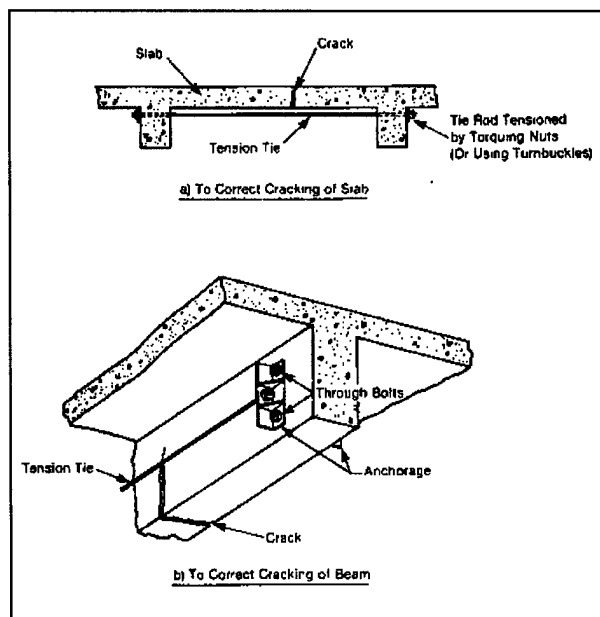
Figure 6-2. Crack repair with use of external prestressing strands or bars to apply a compressive force

(2) Prestressing steel. This technique uses prestressing strands or bars to apply a compressive force (Figure 6-2). Adequate anchorage must be provided for the prestressing steel, and care is needed so that the problem will not merely migrate to another part of the structure. The effects of the tensioning force (including eccentricity) on the stress within the structure should be carefully analyzed. For indeterminate structures posttensioned according to this procedure, the effects of secondary moments and induced reactions should be considered.

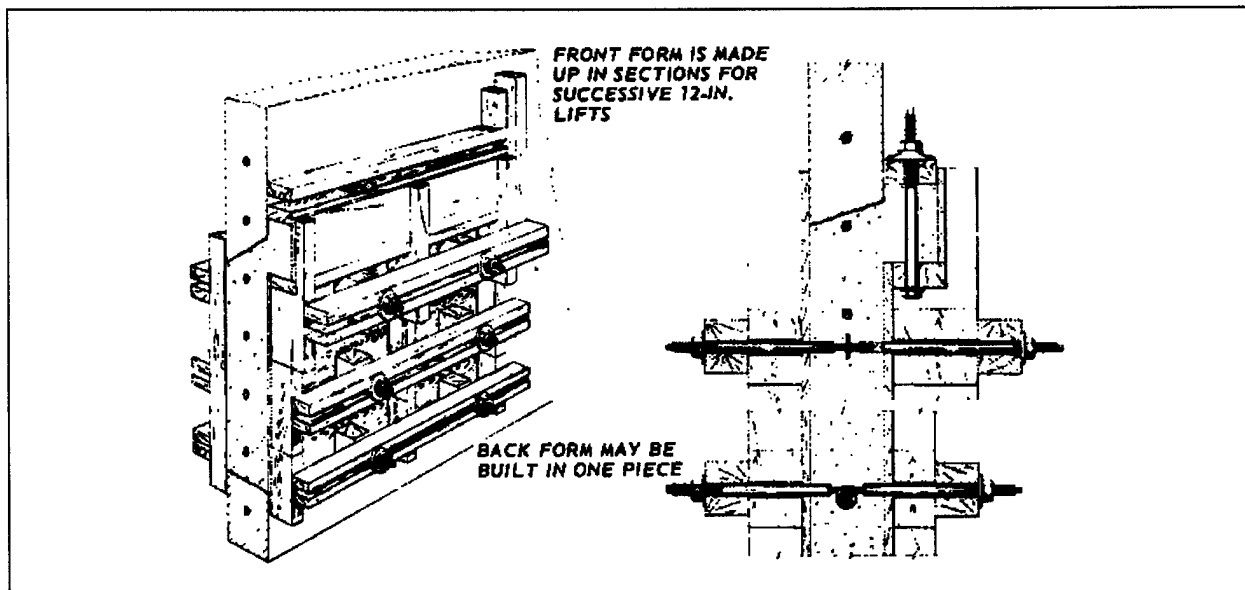
Figure 6-3. Detail of form for concrete replacement in walls after removal of all unsound concrete

(3) Forming will usually be required for massive repairs in vertical surfaces. The front form and the back form, where one is required, should be substantially constructed and mortartight. The back form may be assembled in one piece, but the front panel should be constructed as placing progresses so that the concrete can be conveniently placed in lifts. The contact surface should be dry at the time of patching. Small, thin repairs (less than 50 mm (2 in.) thick) should receive a bonding coat while thicker placements usually do not require a bonding coat (see paragraph 5-3a(2)(f)). The surface is first carefully coated with a thin layer of mortar, not exceeding 3 mm (1/8 in.) in thickness, containing sand passing the No. 16 sieve, and having the same w/c as the concrete to be used in the replacement. Hand-rubbing the mortar into the surface is effective. Epoxy resin

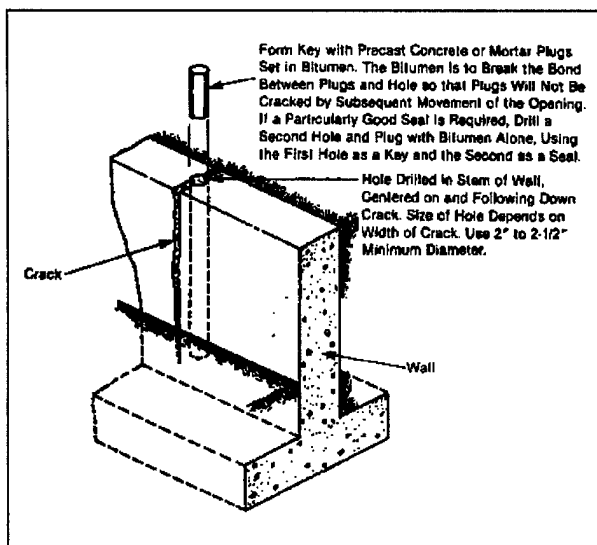
Figure 6-5. Repair of crack by drilling and plugging

a. *Description.* Drilling and plugging a crack consists of drilling down the length of the crack and grouting it to form a key (Figure 6-5).

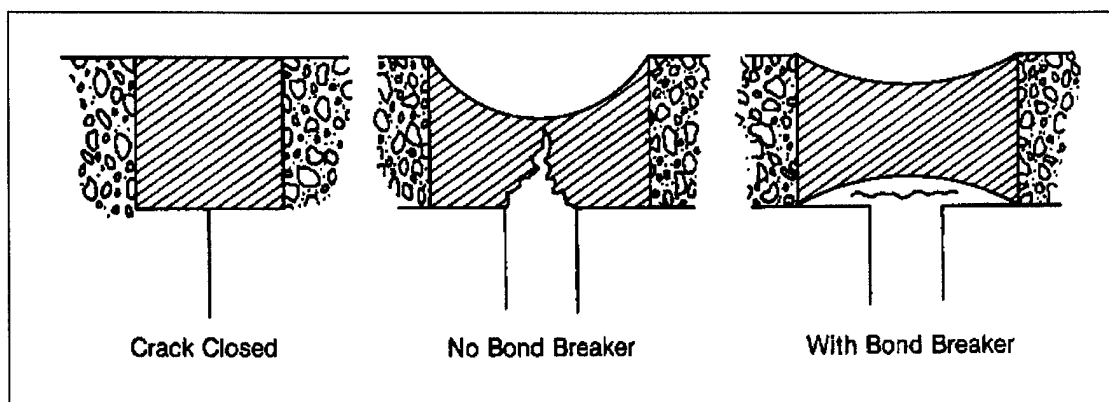
Figure 6-6. Effect of bond breaker involving a field-molded flexible sealant

(1) A bond breaker should be provided at the bottom of the slot to allow the sealant to change shape without a concentration of stress on the bottom (Figure 6-6). The bond breaker may be a polyethylene strip, pressure sensitive tape, or other material which will not bond to the sealant before or during cure.

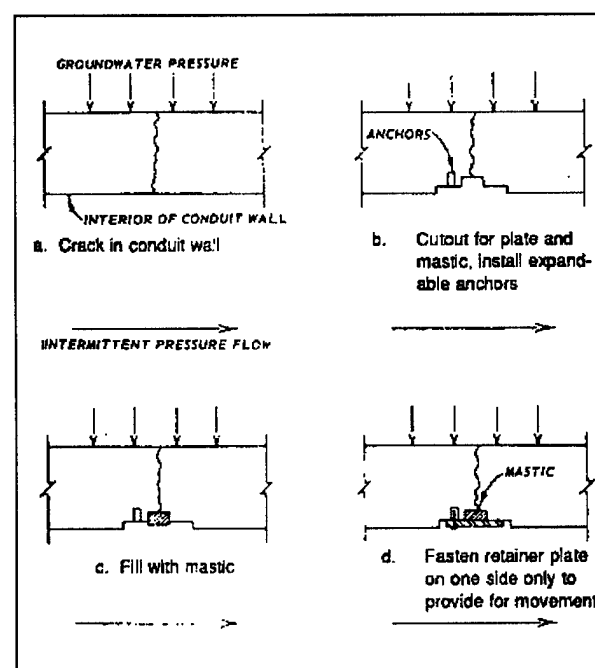
Figure 6-8. Repair of crack by use of a retainer plate to hold mastic in place against external pressure

necessary to cut the concrete surface adjacent to the crack and to place the retaining cap flush with the original flow lines (Figure 6-8).

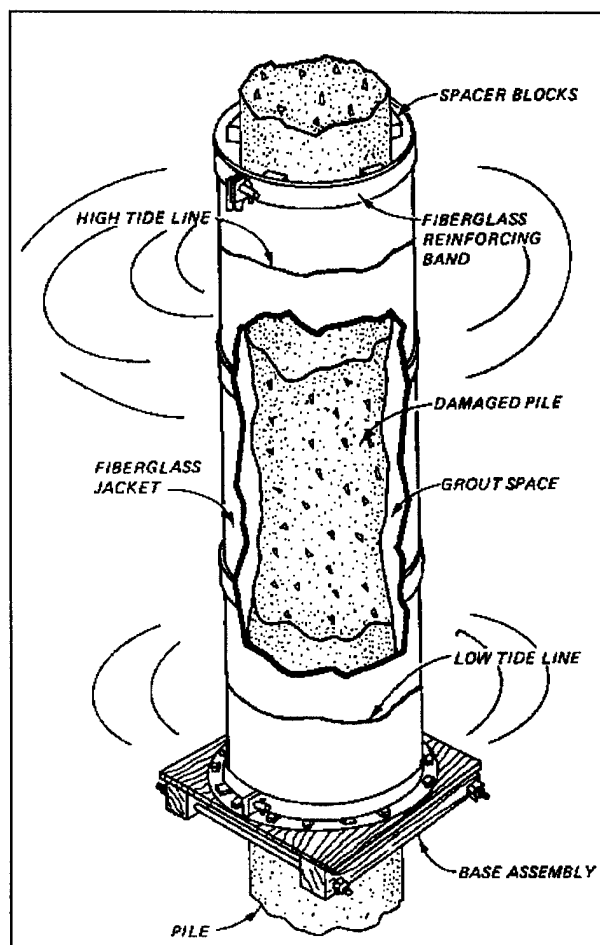
Figure 6-9. Typical preformed fiberglass jacket being used in repair of a concrete pile

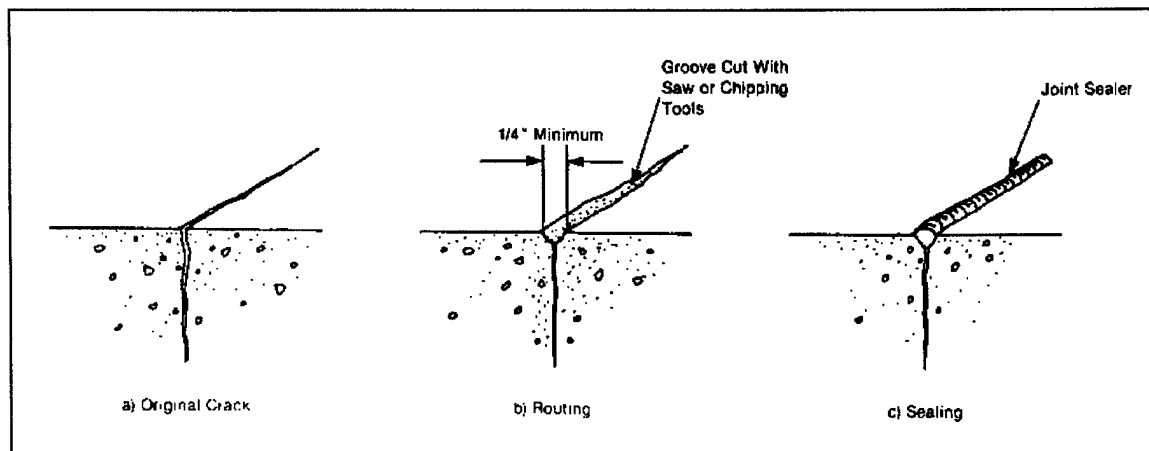
Figure 6-10. Repair of crack by routing and sealing

a. Description. This method involves enlarging the crack along its exposed face and filling and sealing it with a suitable material (Figure 6-10). The routing operation may be omitted but at some sacrifice in the permanence of the repair. This is the simplest and most common method for sealing dormant cracks.

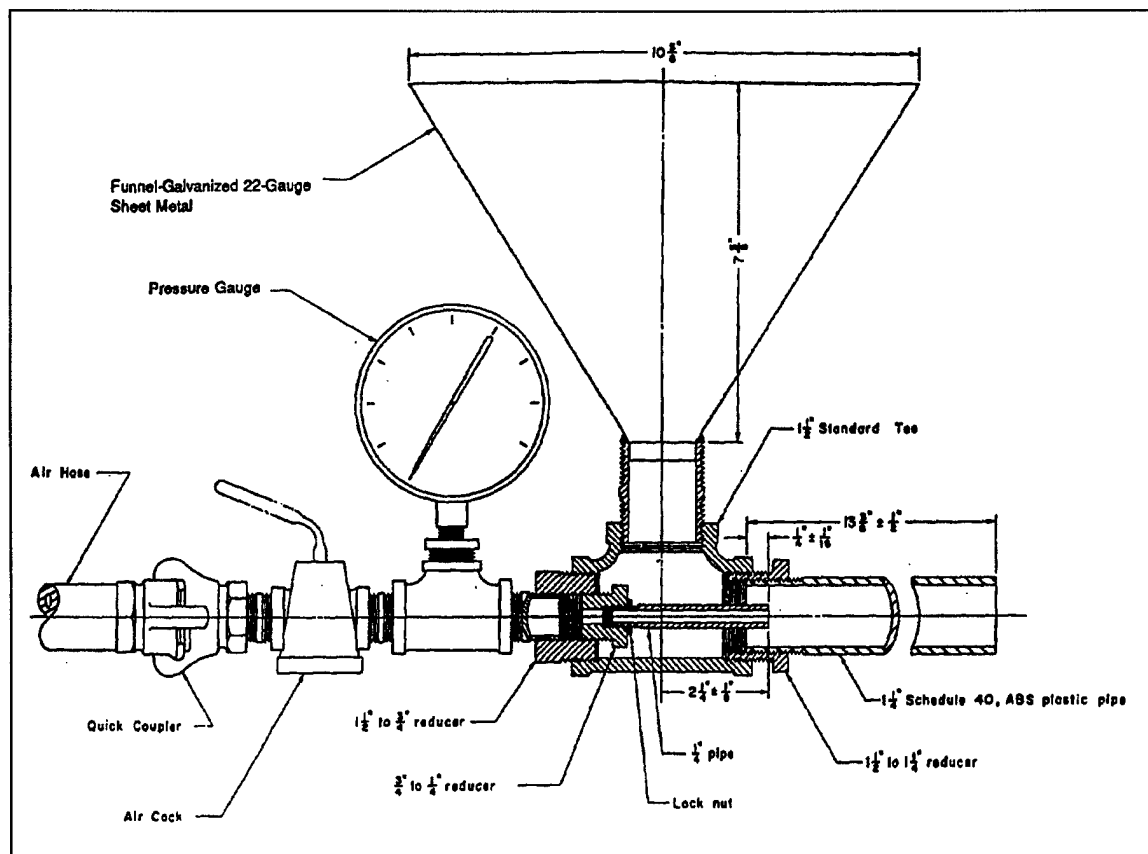
Figure 6-11. Mortar gun for concrete repair (U.S. Army Engineer Division, Missouri River 1974)

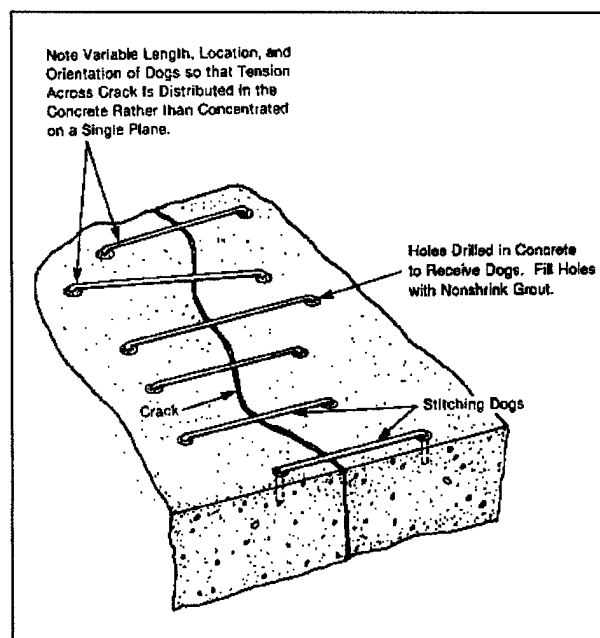
Figure 6-13. Repair of a crack by stitching

b. Applications and limitations. Stitching may be used when tensile strength must be reestablished across major cracks. Stitching a crack tends to stiffen the structure, and the stiffening may accentuate the overall structural restraint, causing the concrete to crack elsewhere. Therefore, it may be necessary to strengthen the adjacent

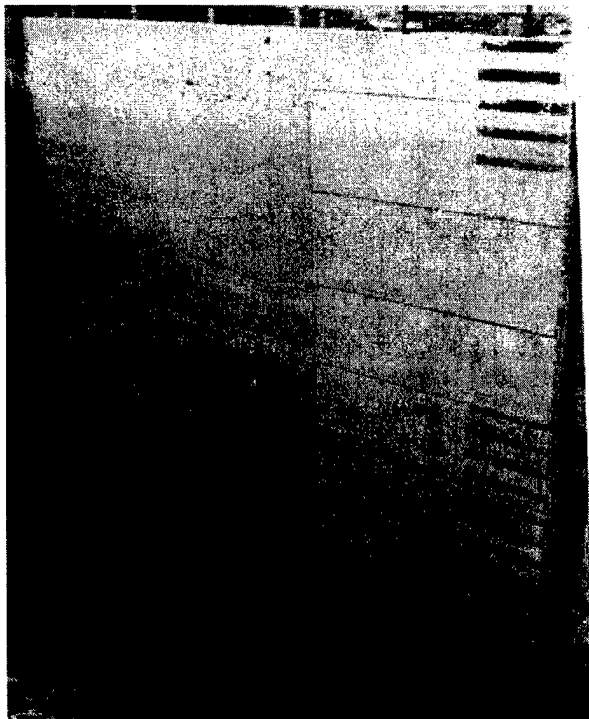
Figure 8-3. Concrete cracking in resurfaced monolith (left) compared to reconstructed monolith, Lock No. 1, Mississippi River

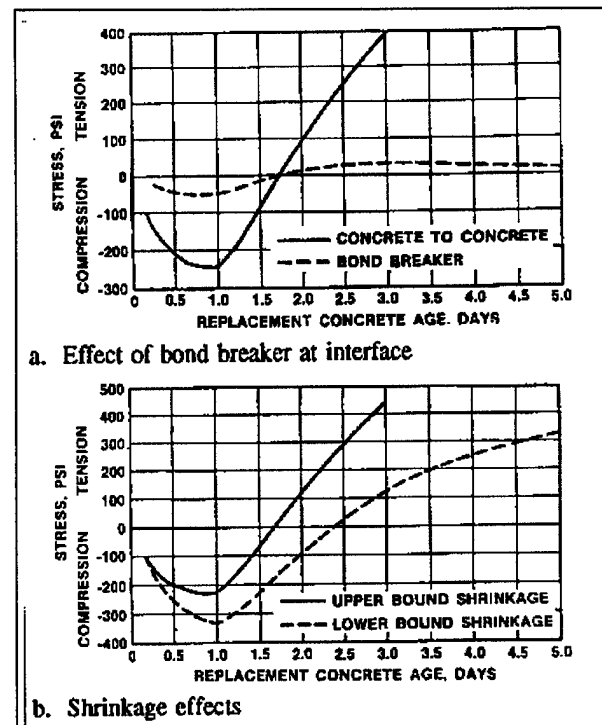
Figure 8-4. Results of a finite element analysis of a typical lock wall resurfacing

(a) A finite element analysis of a typical lock wall resurfacing (Norman, Campbell, and Garner 1988) also demonstrated the effect of restraint by the existing concrete. Under normal conditions of good bond between the two concretes, stress levels sufficient to cause cracking in the replacement concrete developed within about 3 days (Figure 8-4a). In comparison, a bond breaker at the interface resulted in almost no stress in the replacement concrete. The analysis also indicated that shrinkage was a significant factor (Figure 8-4b). Even the lower bound shrinkage resulted in tensile stresses in excess of 2.1 MPa (300 psi).

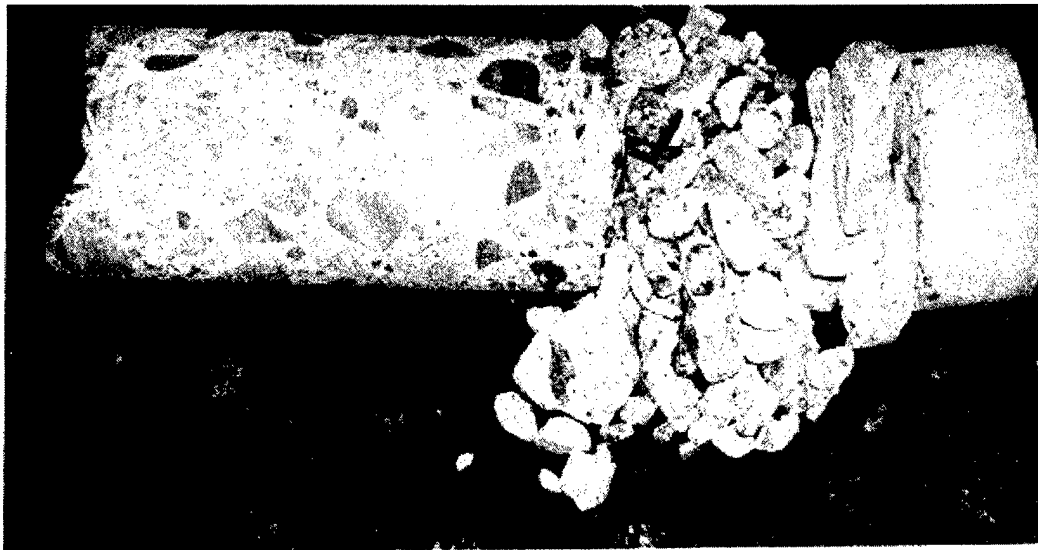
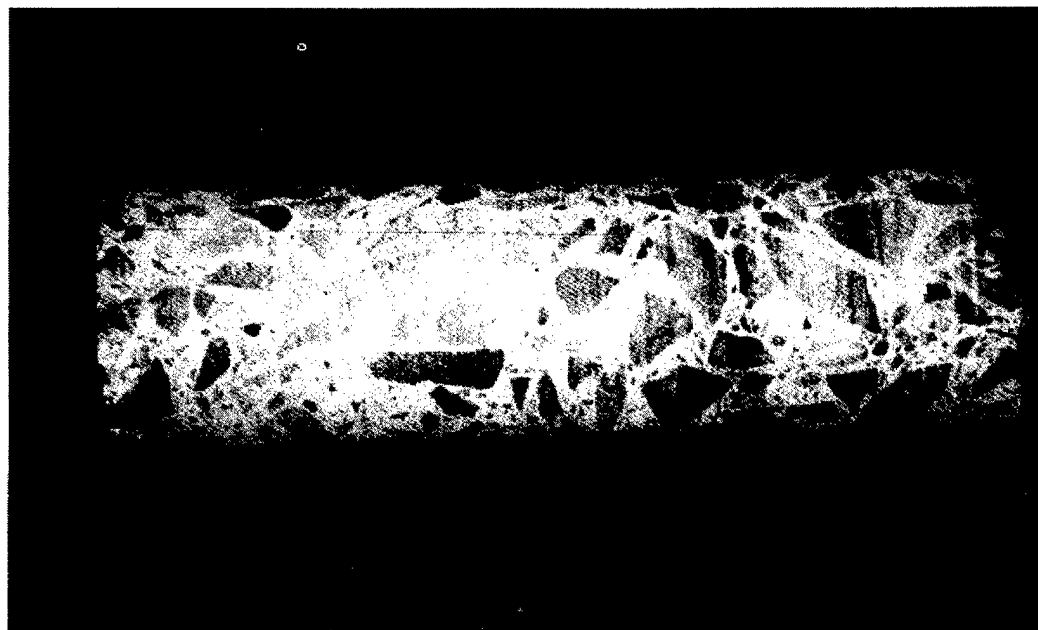
a. Concrete deterioration immediately behind shotcrete overlay

b. Concrete not refaced with shotcrete

(d) The concrete in the walls of Lower Monumental Lock has an inadequate air-void system to resist damage caused by freezing and thawing while critically saturated. After approximately 10 years in service, the concrete had deteriorated to the point that the aggregate was exposed. After laboratory tests and a full-scale field test which demonstrated that a 10-mm (3/8-in.)-thick latex-modified fiberglass-reinforced spray-up coating had the potential to meet repair requirements, which included time constraints on the lock downtime that precluded conventional concrete replacement (Schrader 1981), the lock walls were repaired (Figure 8-10) in 1980. In March 1983 several small isolated areas of debonded coating (less than 1 percent of the total area) were identified in the lock. The coating in these locations was removed and the areas resprayed similar to the original repair. Also, a fairly large debonded zone in monolith 11 was repaired. A September 1983 inspection reported the original coating to

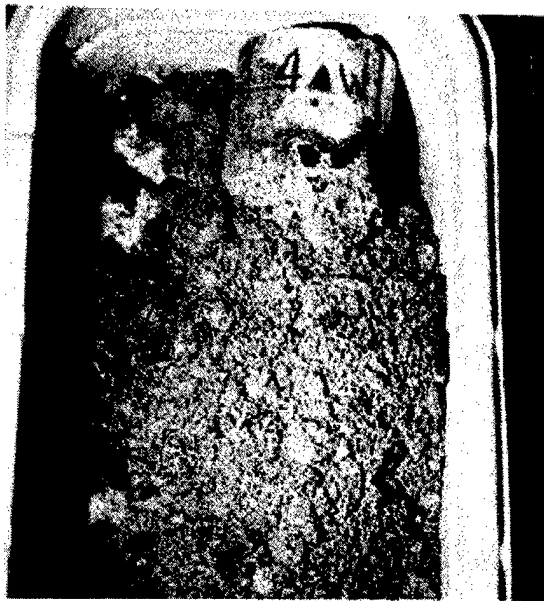
b. After freezing and thawing

Figure 8-8. Combination shotcrete and concrete core before and after 35 cycles of freezing and thawing in a saturated condition

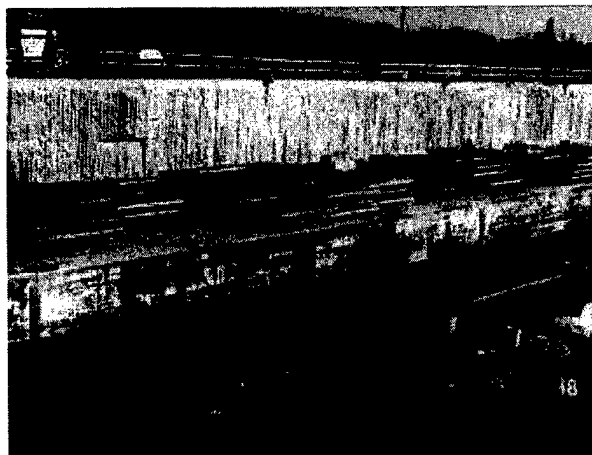
Figure 8-14. Installation of precast concrete stay-in-place forms at Lock 22, Mississippi River

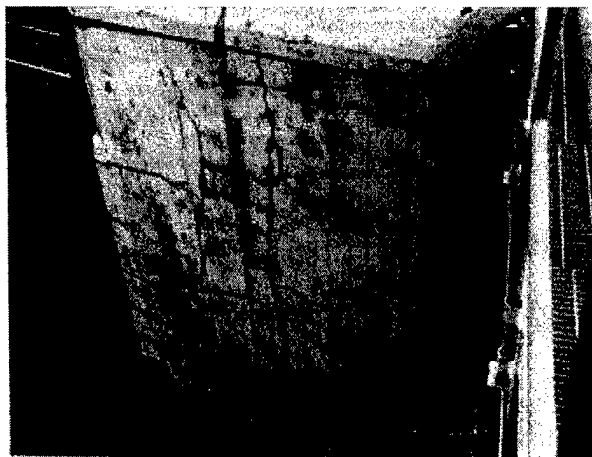
Figure 8-16. Typical cracking in miter gate monoliths resurfaced with cast-in-place concrete, Troy Lock, Hudson River (Miles 1993)

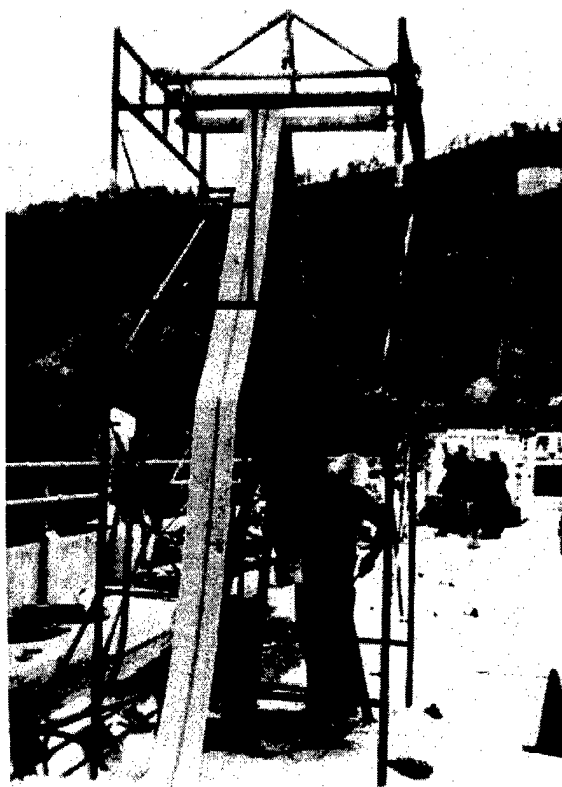
Figure 8-24. Inversion apparatus for installing tube in drill hole, Pine Flat Dam

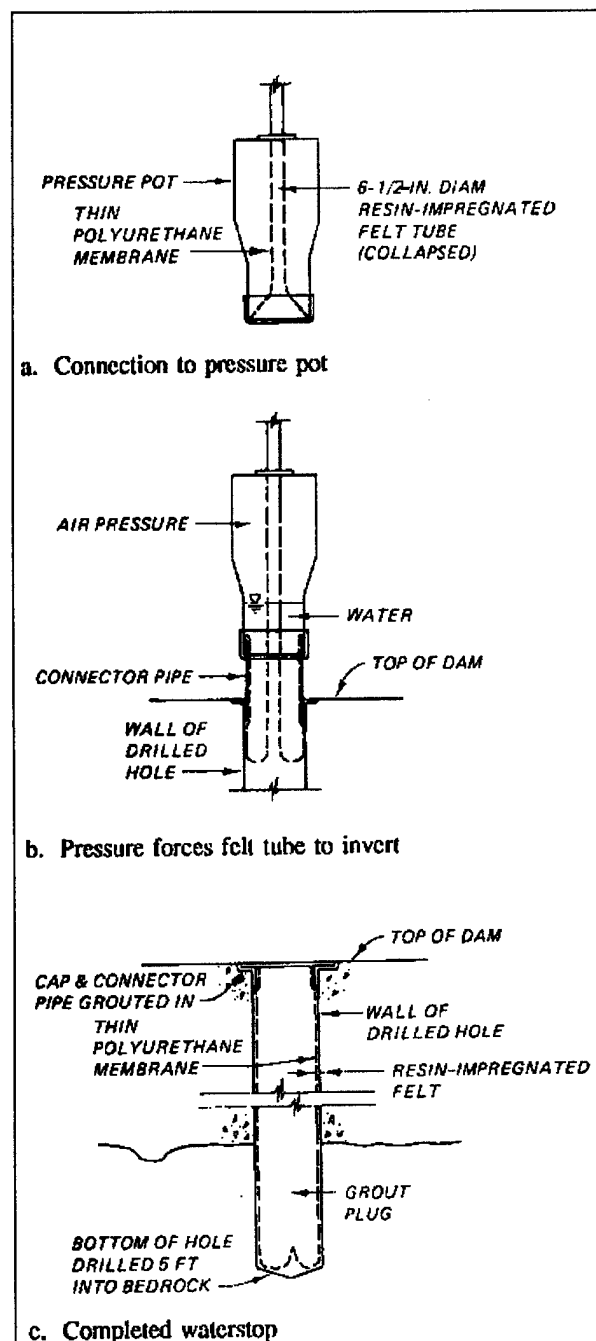
Figure 8-25. Remedial waterstop installation, Pine Flat Dam

(1) *Interior joints.* The repair procedure consists of drilling an array of small-diameter holes from various locations within the gallery or conduit to intercept the

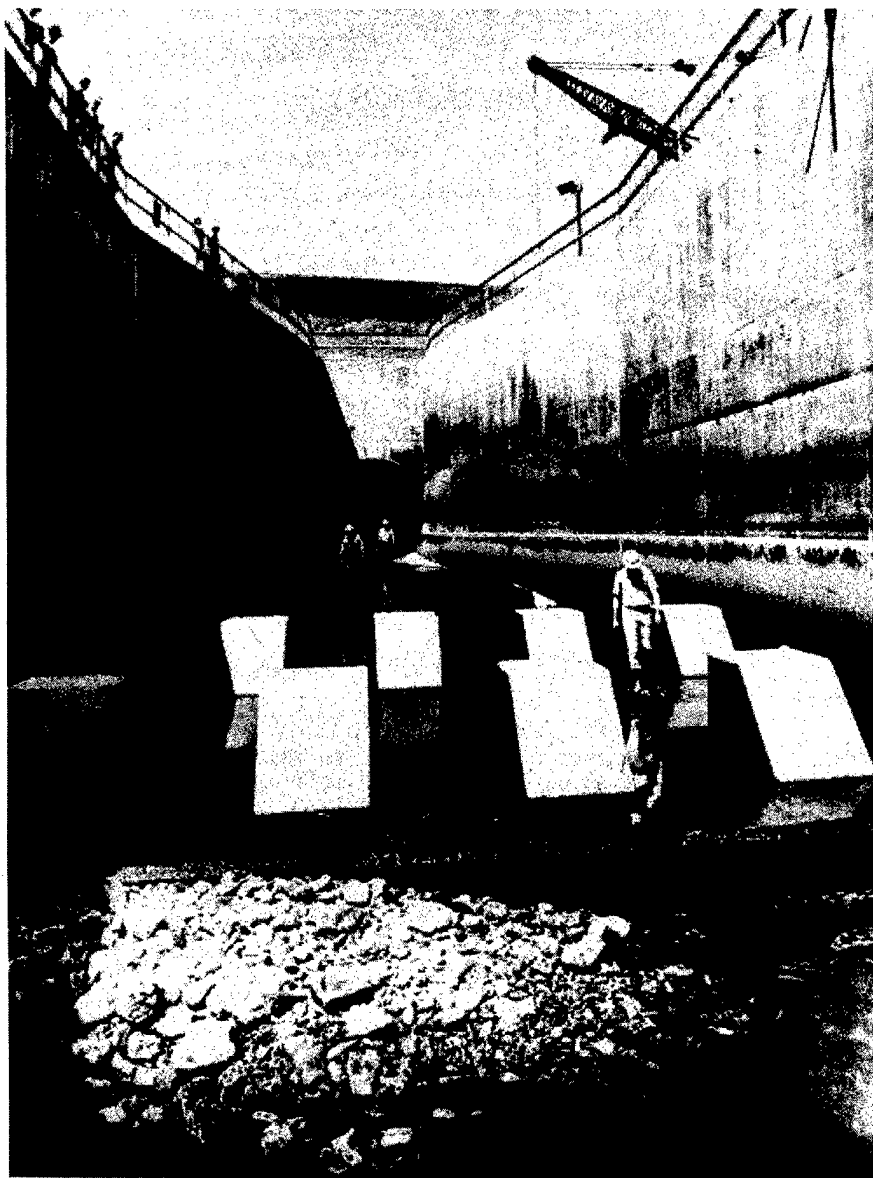
Figure 8-30. Stilling basin dewatered for inspection, Pomona Dam

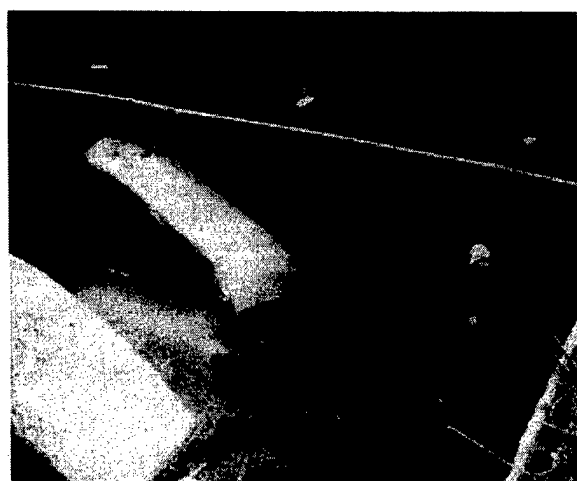
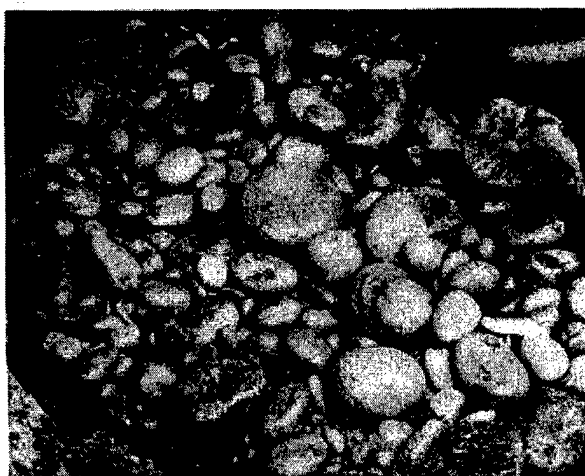
a. Scour holes behind baffles

b. Debris in scour holes

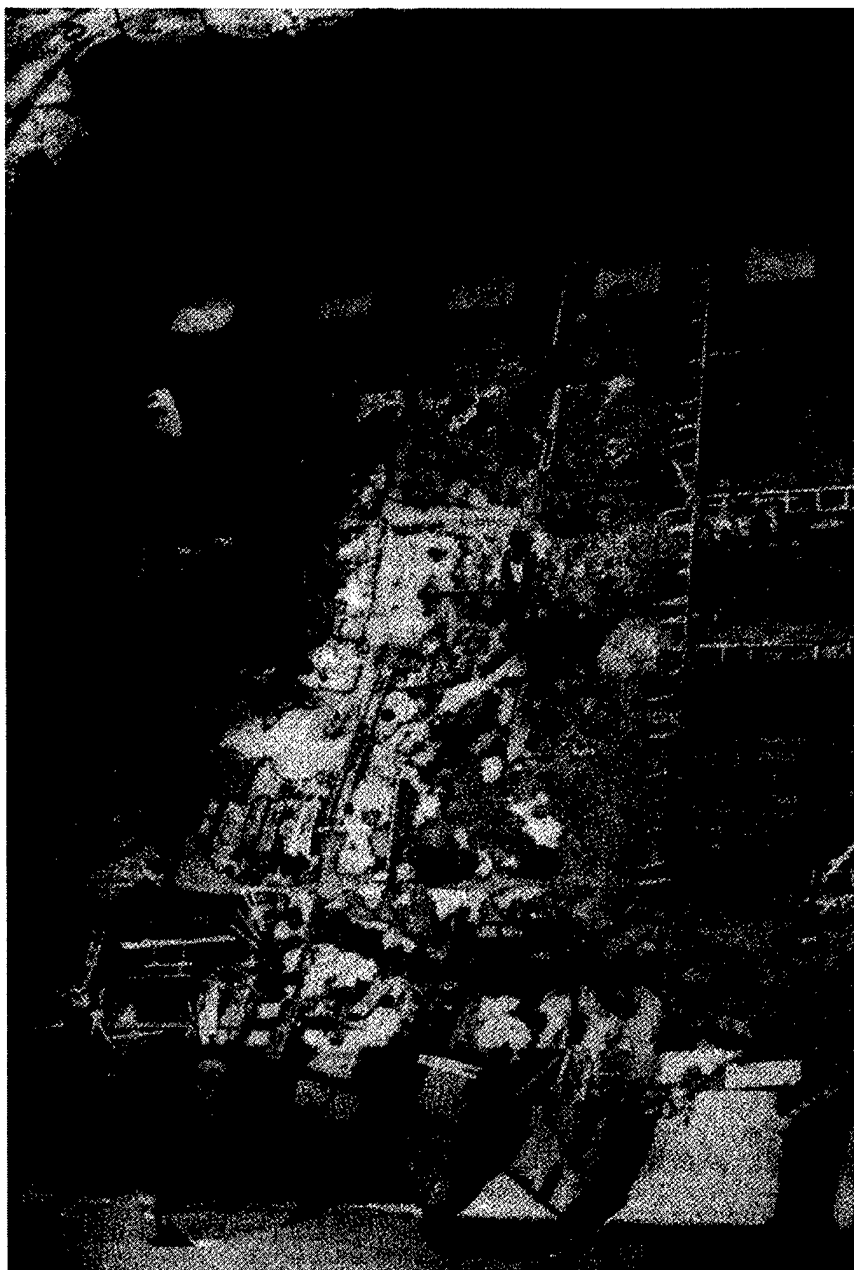
Figure 8-34. General view of repair operations, Kinzua Dam, 1974
